ZAVOD ZA
GRADBENIŠTVO
SLOVENIJE

Radon mitigation in Slovenia

Dresden, 2. - 3. December 2013

Radon protection conference

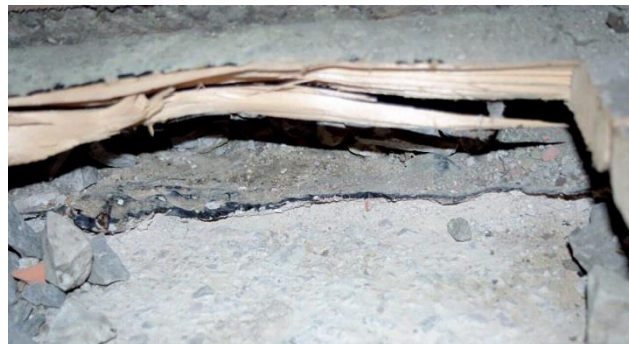
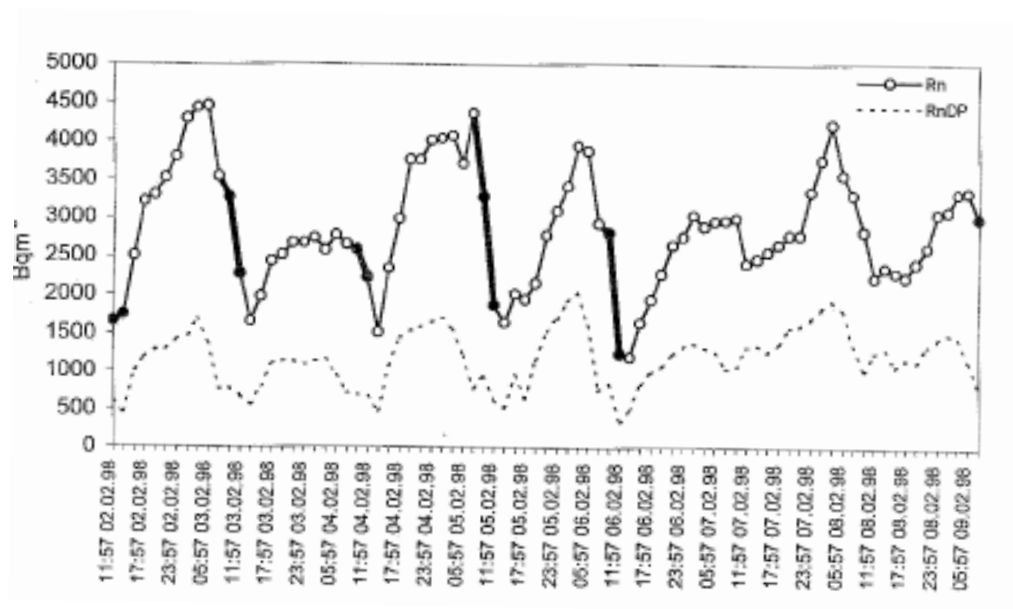
Janče

- Radon source is fly ash in void
- Minigation: removal of fly-ash and ventilation
- Concentration reduction
 - Before: 1020 Bq/m^3
 - After: $< 400 \text{ Bq/m}^3$

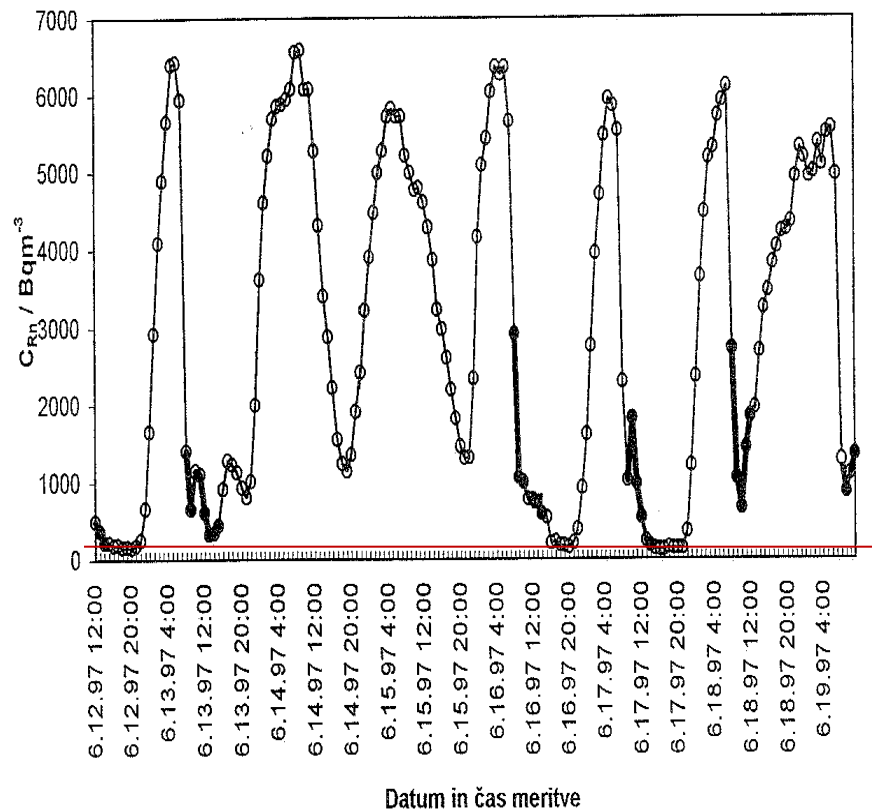
Lokev pri Sežani

- Large void in structure
- Floor reconstructed
 - Drainage system introduced
- Ventilation in chimney
- First operation successful, but fan failure due to poor fan selection
- Second operation very successful ($C_{Rn} < 200$ Bq/m³)

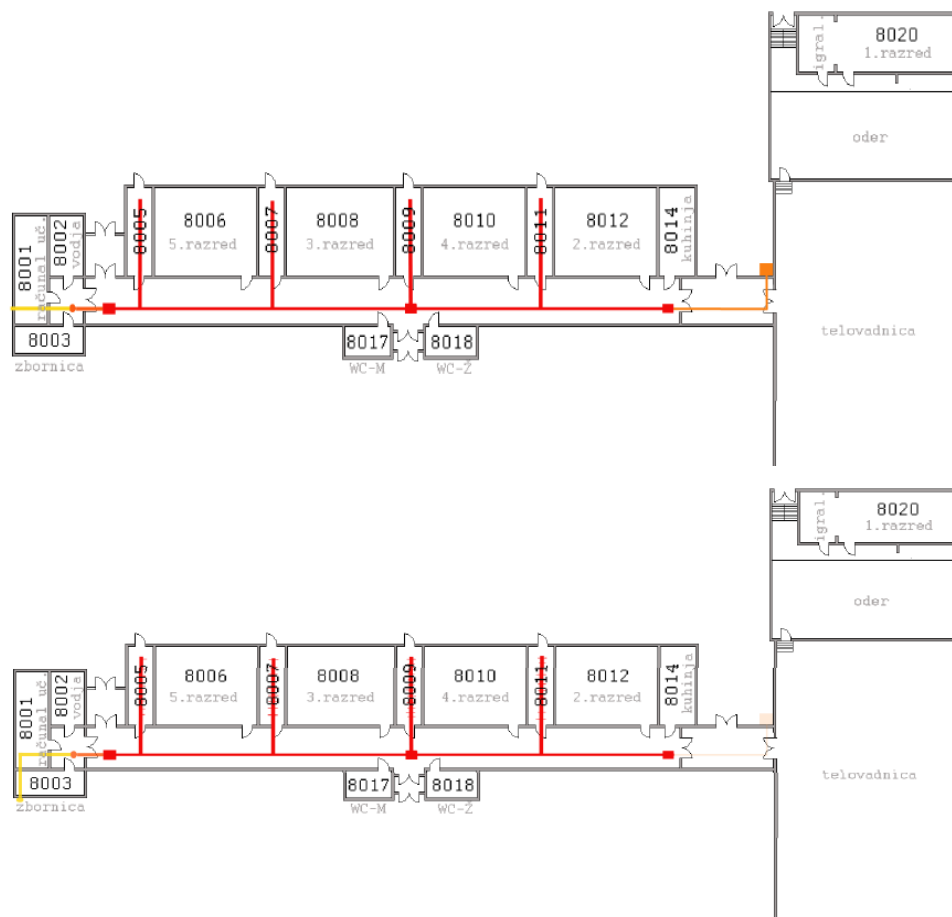
Case Dolenja Vas (1997)

- Initial: 600 - 4000 Bqm⁻³
- Final: 100 – 500 Bqm⁻³
- First mitigation: shaft ventilation
- Second mitigation: extension
- Third mitigation: new exhaust

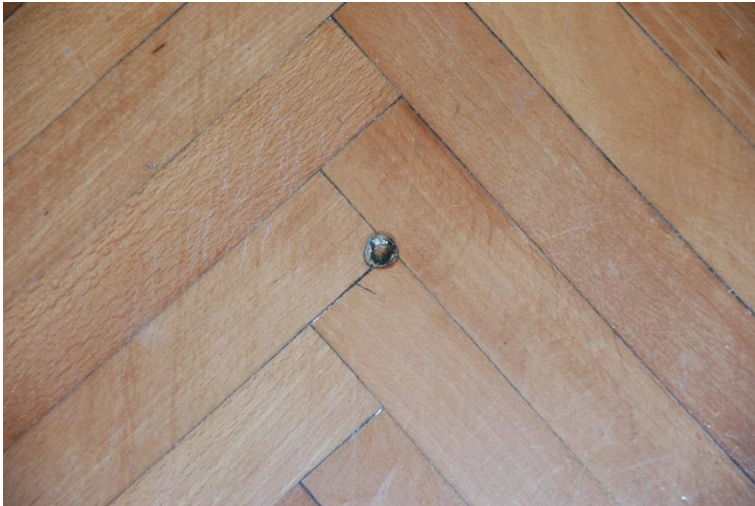
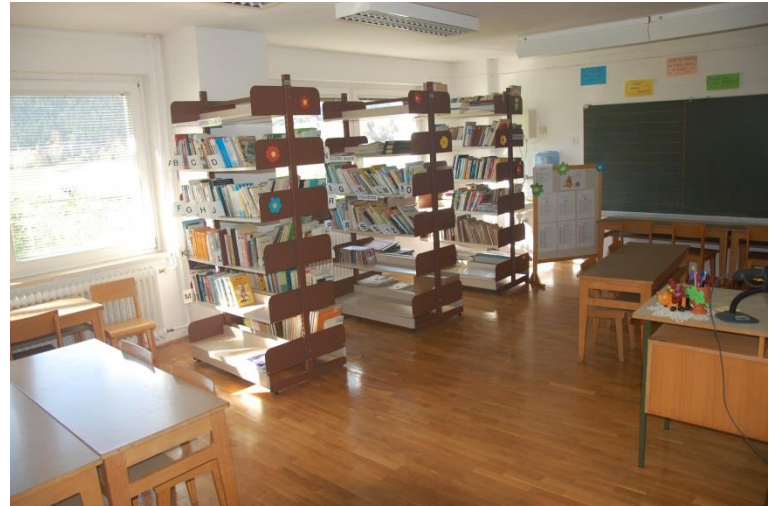
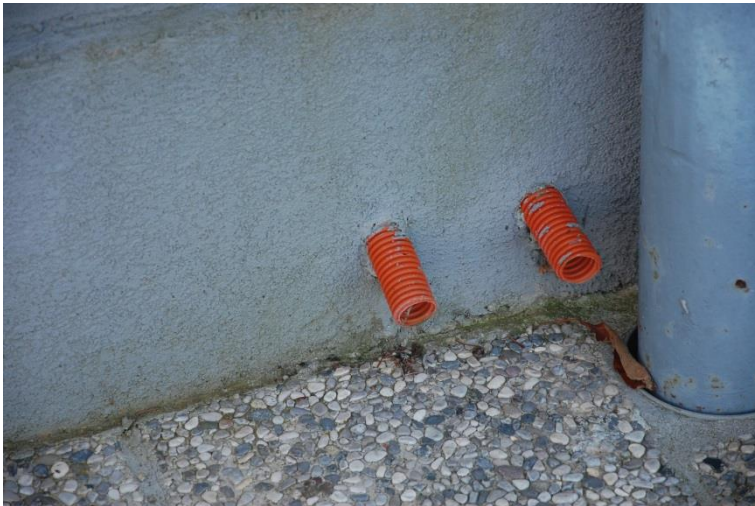
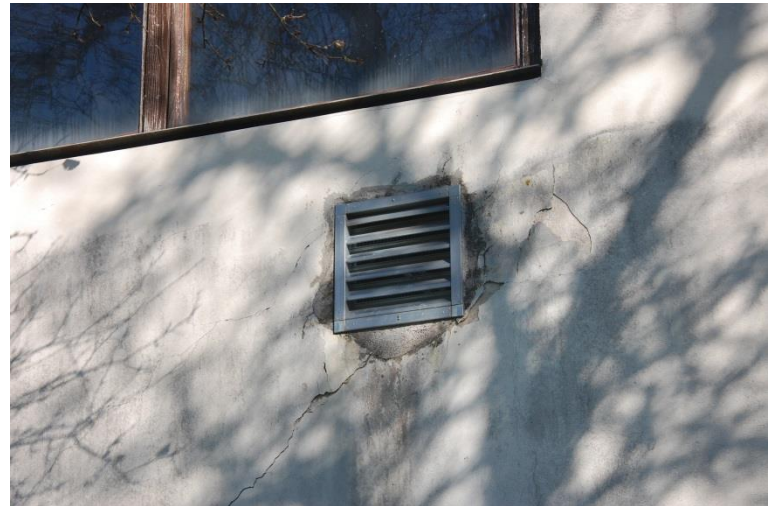
Case Dolenja vas (revisited)

- Mitigation successful when commissioned
- Some modifications done afterwards (facade – air feed-in due to lack of understanding)
- New floor in library
 - Problems with sealed floor (seen very soon)
- Effect of modifications on mitigation system not known
- Change of personell dilutes instructions passed at set-up

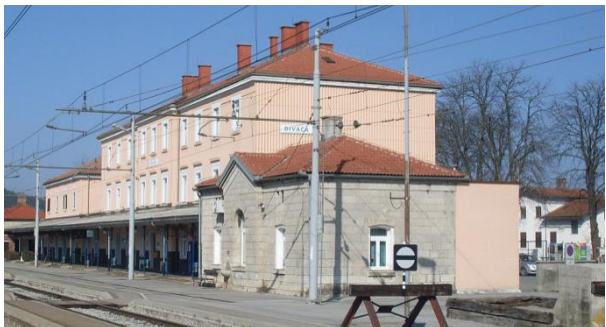
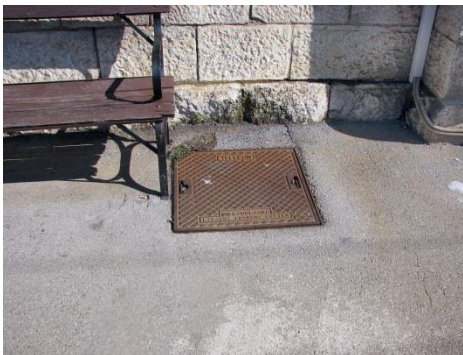
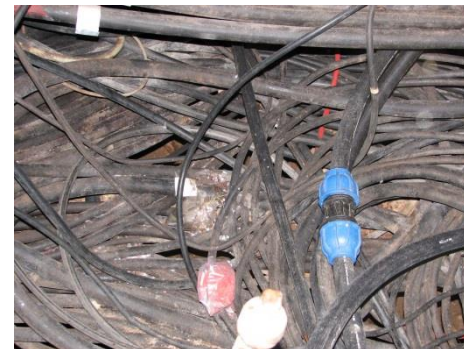
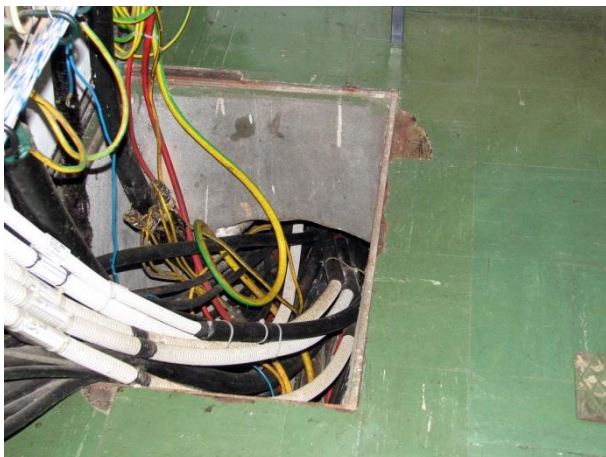
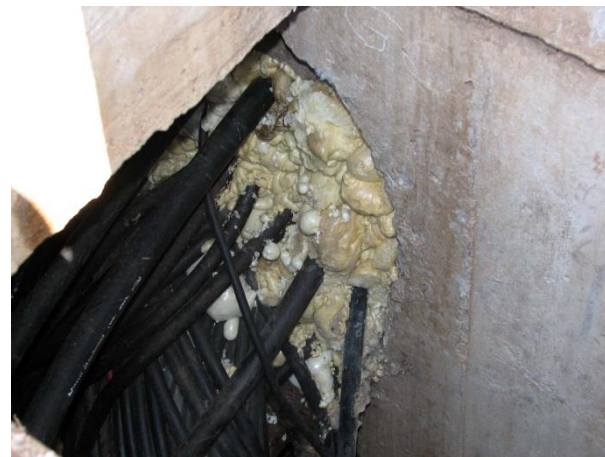
Divača

- Railway controll room
- Radon entering via large floor opening
- Opening connected to underground signalization system
 - No modification allowed due to safety reasons
 - Underground „collector“ about 5 km long – no ventilation or overpressure is possible
- Solution:
 - Instant: increased natural ventilation
 - Discussed (but not realized): mechanical ventilation with overpressure scheme

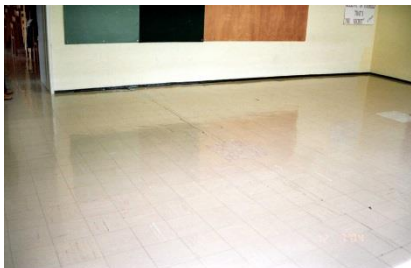
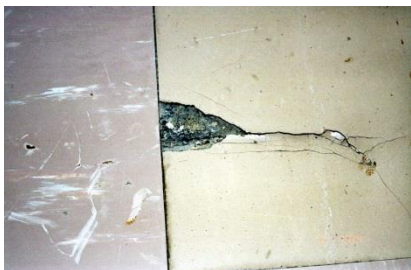
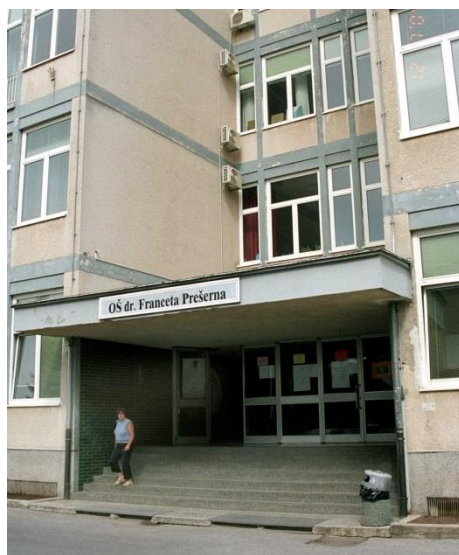
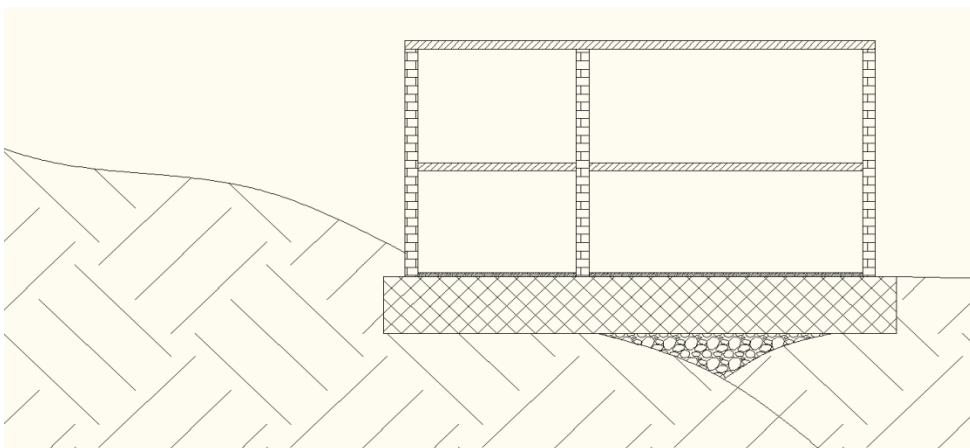
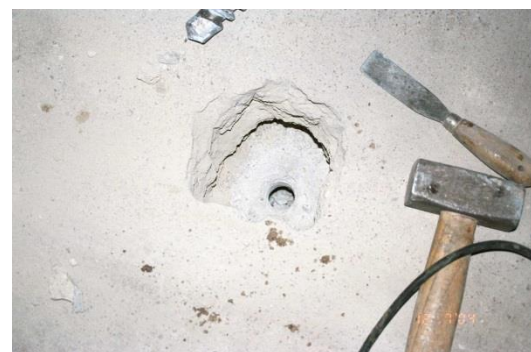
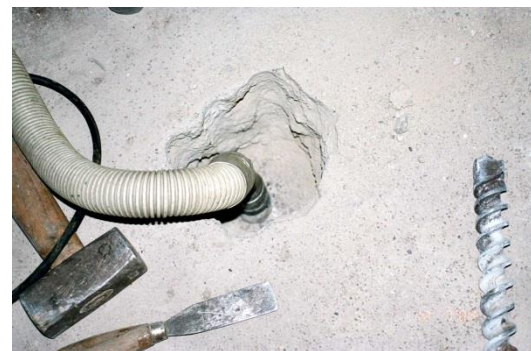
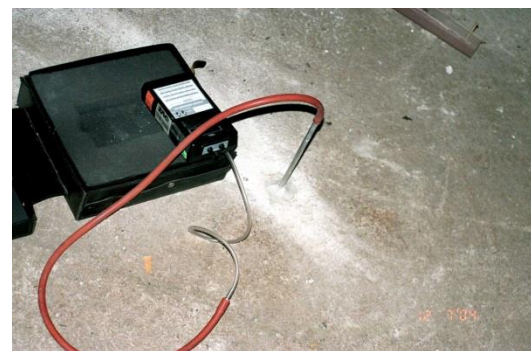
Ribnica

- School exhibits high concentrations
- Analyzing blueprints following is found
 - The building lies on 140 cm thick concrete
 - Reason: pit beneath, leading into minor karst cave
- Exploring the possibilities it becomes clear:
 - No SSD possible due to very high volume to be ventilated
 - No overpressure possible due to central position of rooms in question
 - Sealing virtually impossible in technical rooms due to installations
- Solution:
 - Limited access and use of rooms
 - Exploring possibilities for ventilation via shafts

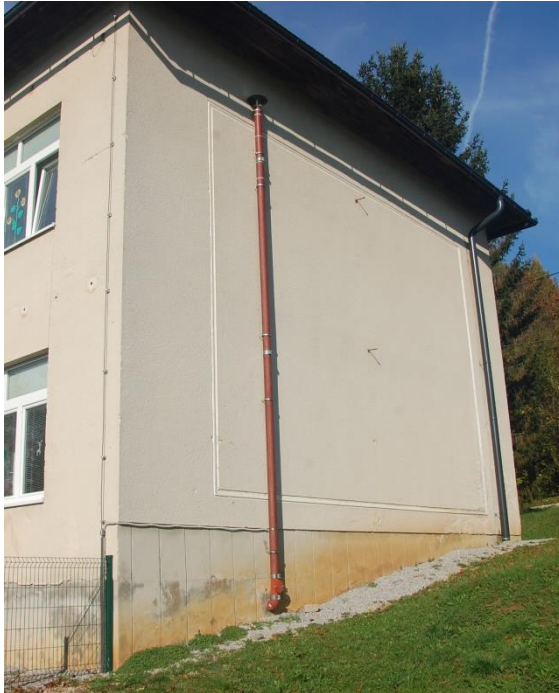
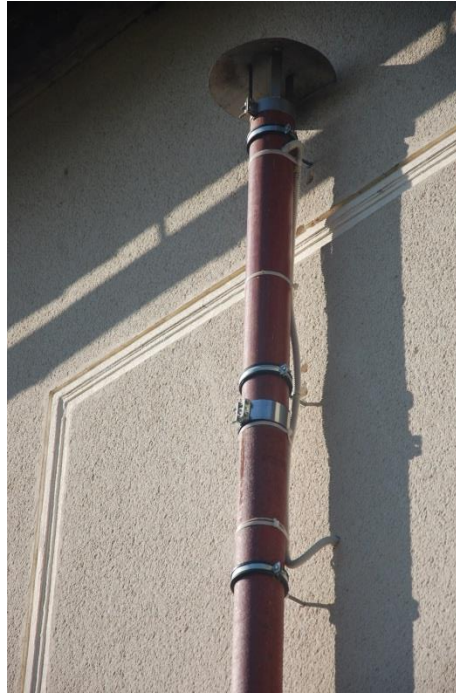
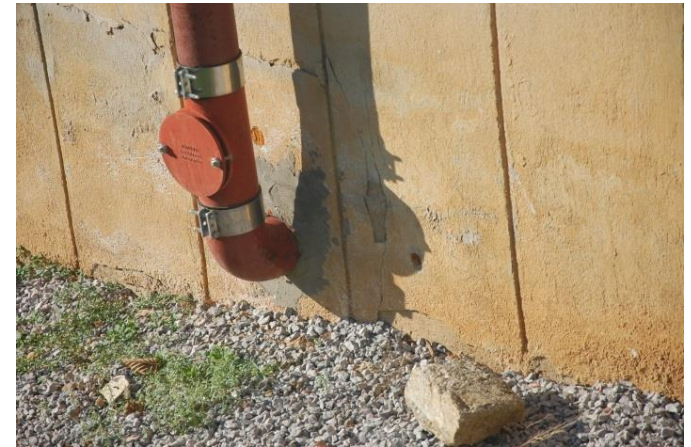
Case Muljava

- Concentration
 - Before 4000 Bqm⁻³
 - After 380 Bqm⁻³
- The system in crucial points as designed
- Alterations in material selection
 - Increased drag
 - Possible issues on durability / condensation
- No monitoring has been installed to monitor pressure
 - Risk of unnoticed failure
- Results of control measurements OK

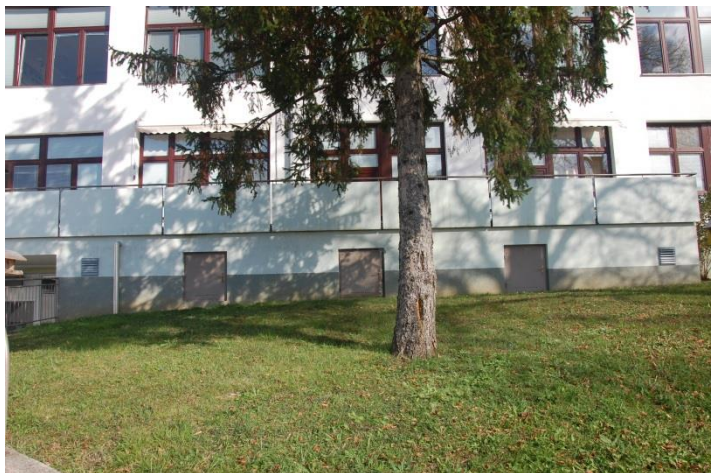
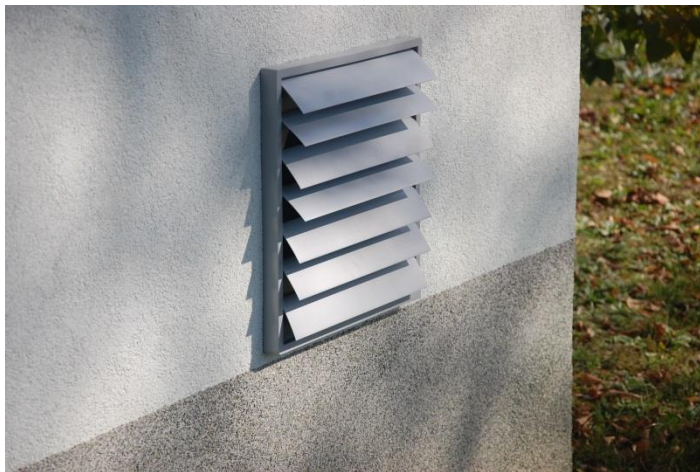
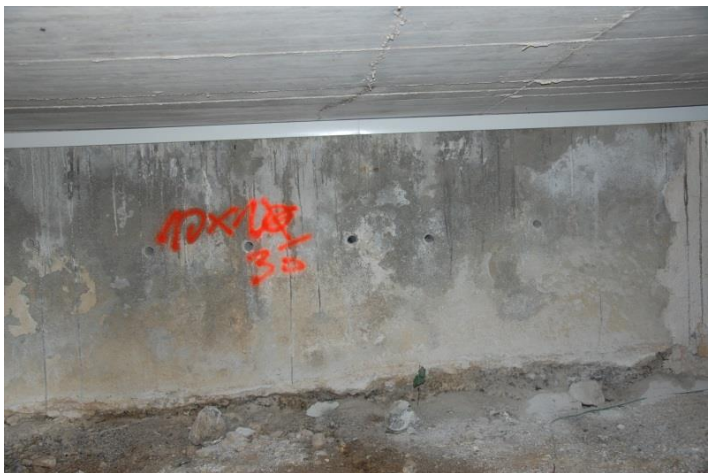
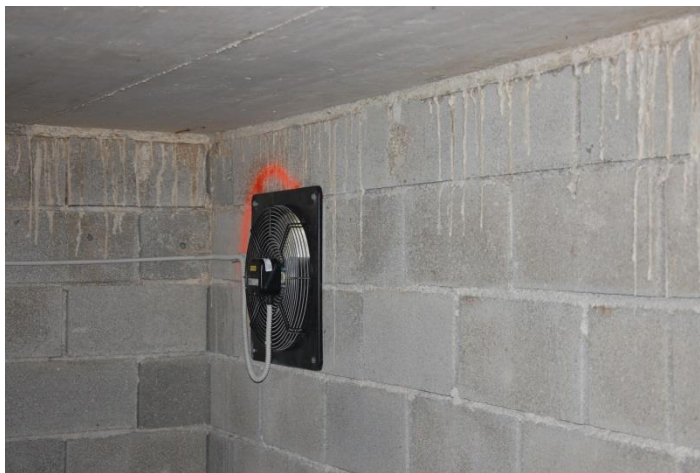
Prevole

- Mitigation strategy was prepared
- Due to small space problems with execution were expected
- The owner modified mitigation strategy
 - Without notice or consultation
 - Reason claimed: mainly difficult accessibility
- Real problems:
 - Lack of understanding the principles of the system
 - Unskilled technical personnel in the building
 - Distributed tasks
 - Organization of school system

- Measurements not yet done
- Expected insufficient effect in spite of obvious effect of the ventilator
 - We have assessed that the vent is simply moving outside air
- Inspectorate is alerted about the intervention

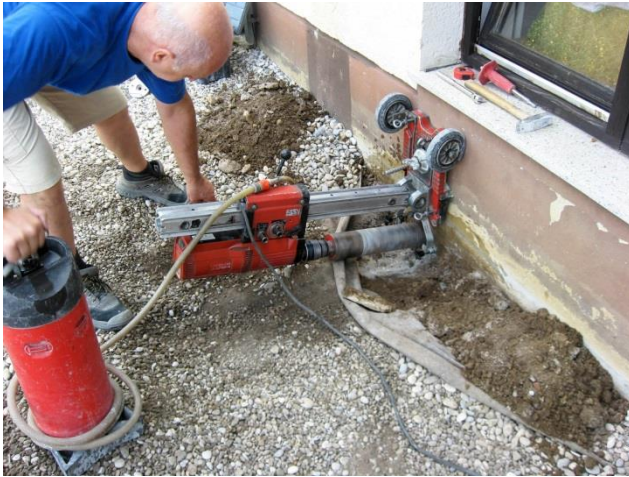
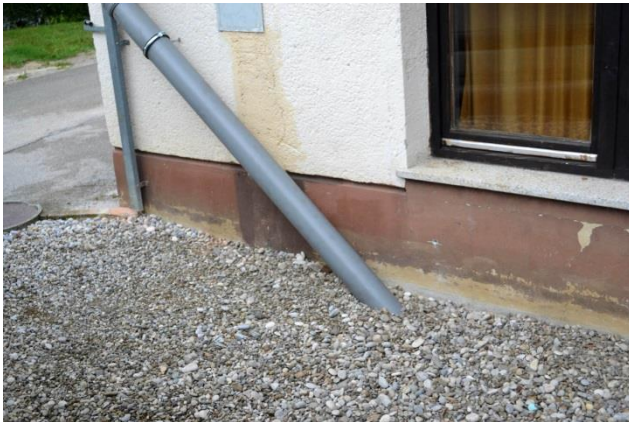
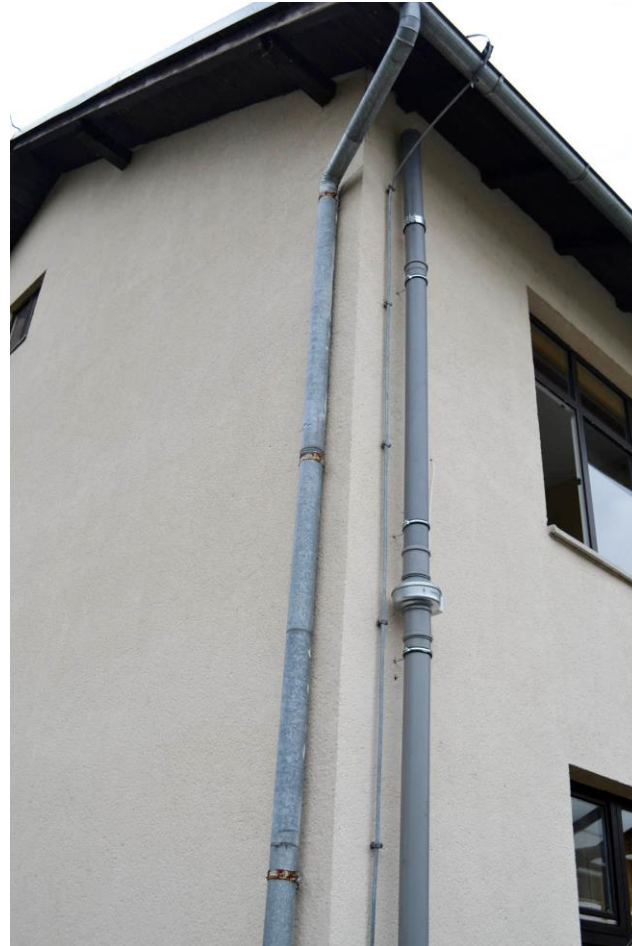
Case Vavta vas

- Concentration dropped
 - Before: 1750 Bqm⁻³
 - After: 170 Bqm⁻³
- Whole solution approach
 - Design
 - Pilot installation
 - Unofficial measurements
 - Recommendations for improvements
- The system exhibited unexpected behaviour at first
- After adjustement good results
- However: due to lack of concern
 - No official measurements ordered so far
 - No proper commissioning done
