ZAVOD ZA
GRADBENIŠTVO
SLOVENIJE

Radon mitigation in Slovenia

Dresden, 2. - 3. December 2013

Radon protection conference

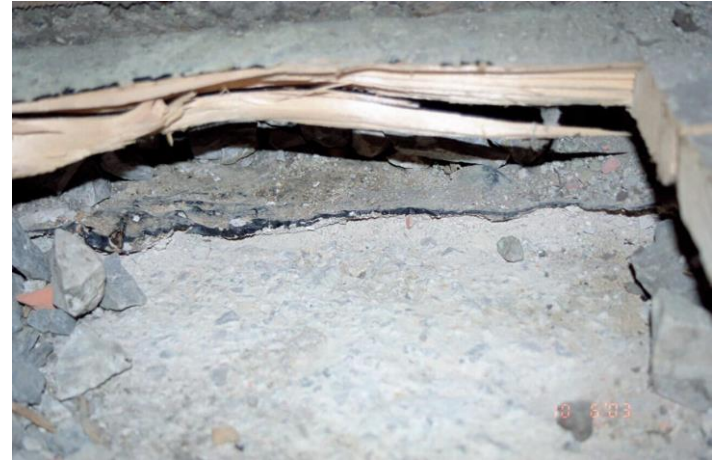
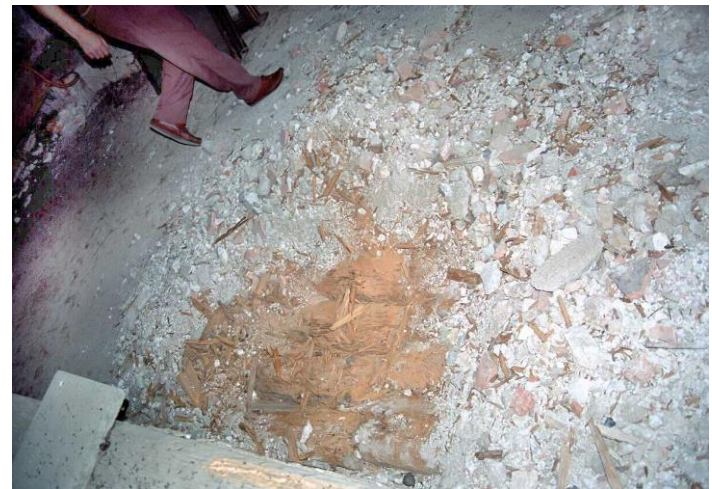
Knowing what you are dealing with

- Usually needed intervention
 - Opening the structure
 - Water barrier?
- Often found critical: knowledge – details on shafts
 - Unexpected difficulties (e.g. Sealed access)
- Important: detailed inspection to minimize intrusion

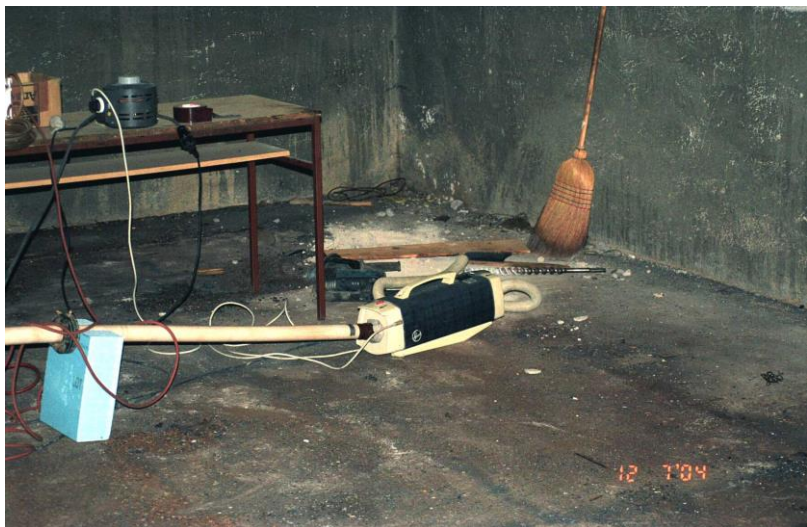
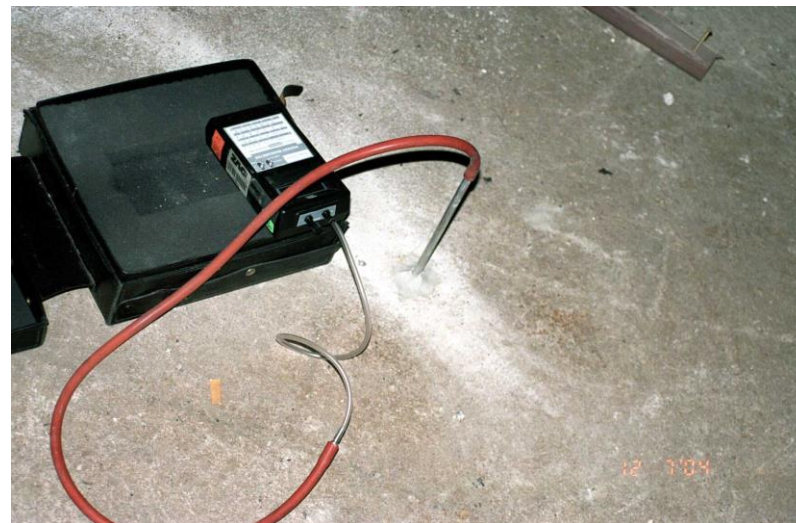
Difficulties

- Sometimes no pressure communication is found
 - Very tight or very loose structure

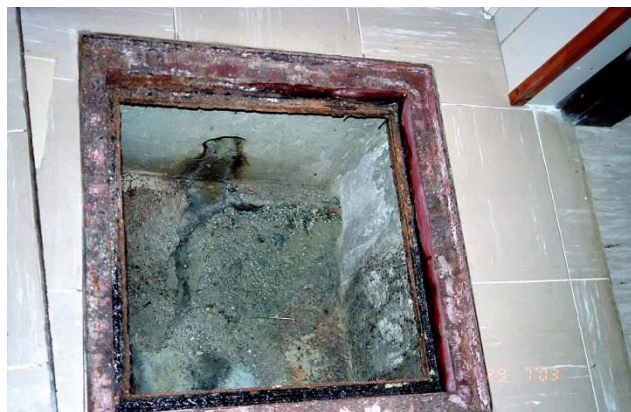
Case Dolenja Vas (1997)

- Initial: 600 - 4000 Bqm⁻³
- Final: 100 – 500 Bqm⁻³
- First mitigation: shaft ventilation
- Second mitigation: extension
- Third mitigation: new exhaust

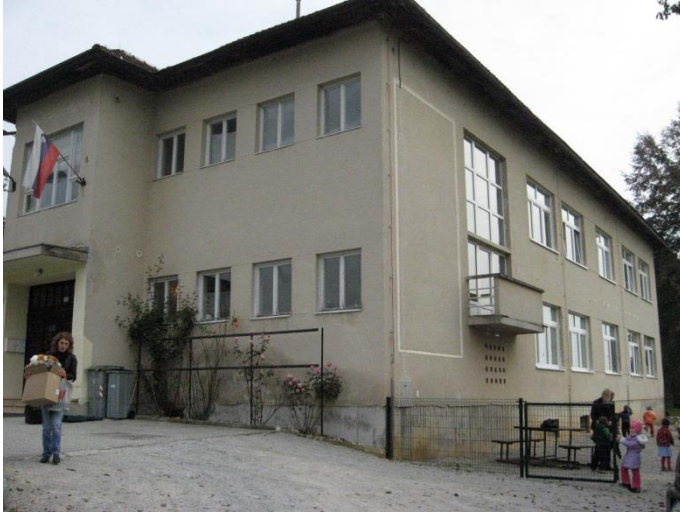
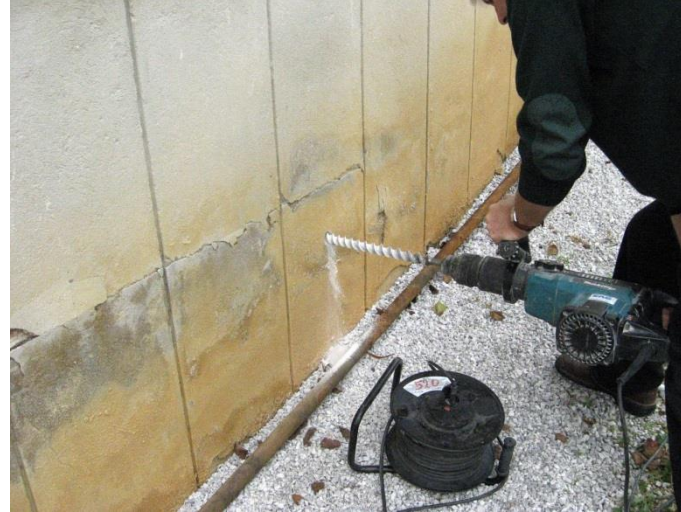
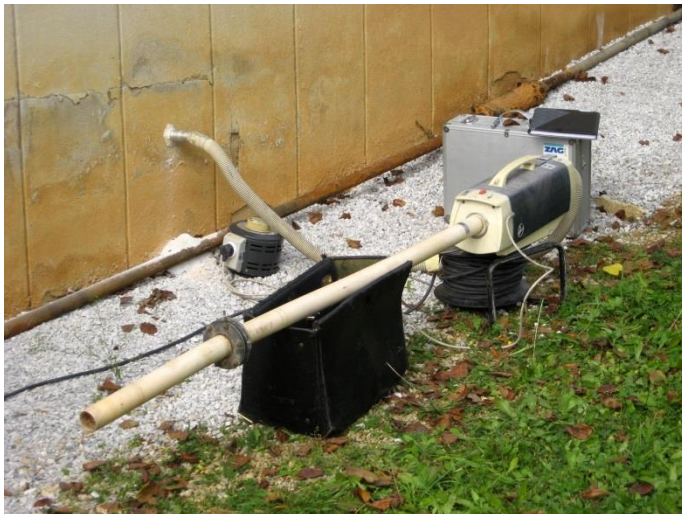
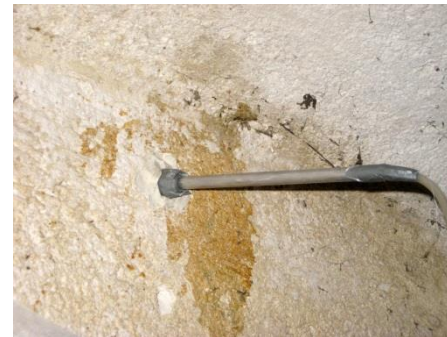
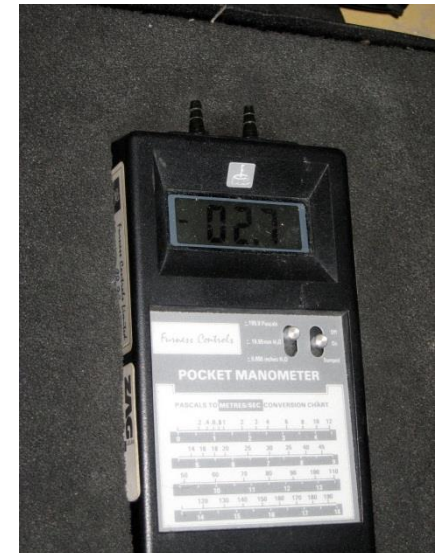
Case Muljava (2010-2011)

- Concentration
 - Before 4000 Bqm⁻³
 - After 380 Bqm⁻³
- The system in crucial points as designed
- Alterations in material selection
 - Increased drag
 - Possible issues on durability / condensation
- No monitoring has been installed to monitor pressure
 - Risk of unnoticed failure
- Results of control measurements OK

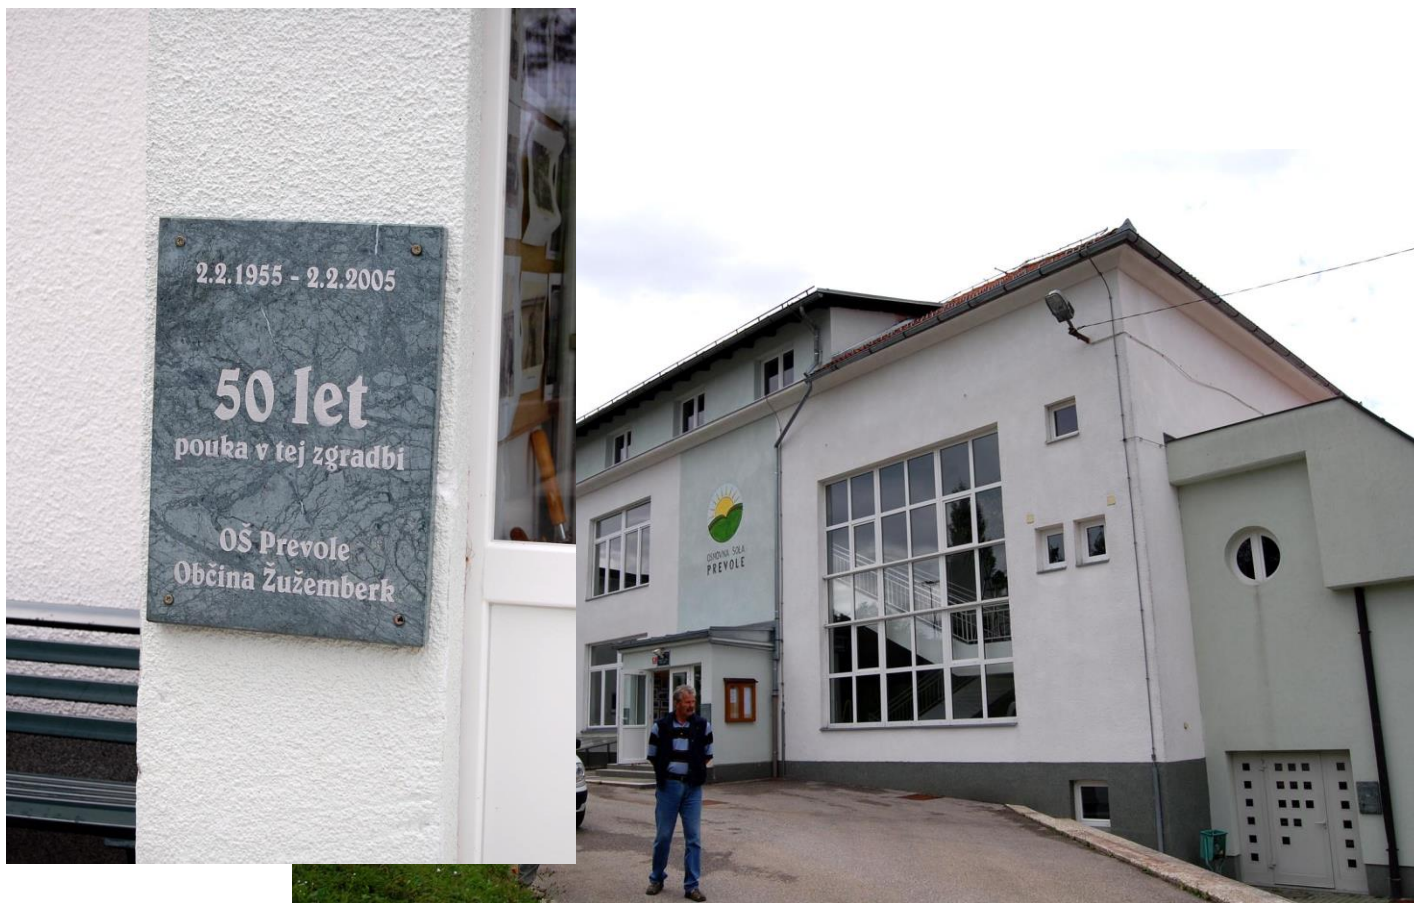
Prevole (2011-2012)

- Mitigation strategy was prepared
- Due to small space problems with execution were expected
- The owner modified mitigation strategy
 - Without notice or consultation
 - Reason claimed: mainly difficult accessibility
- Real problems:
 - Lack of understanding the principles of the system
 - Unskilled technical personnel in the building
 - Distributed tasks
 - Organization of school system

- Measurements not yet done
- Expected insufficient effect in spite of obvious effect of the ventilator
 - We have assessed that the vent is simply moving outside air
- Inspectorate is alerted about the intervention

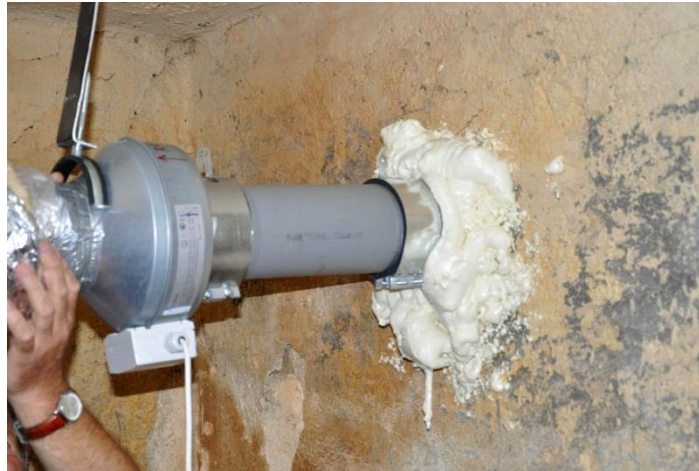
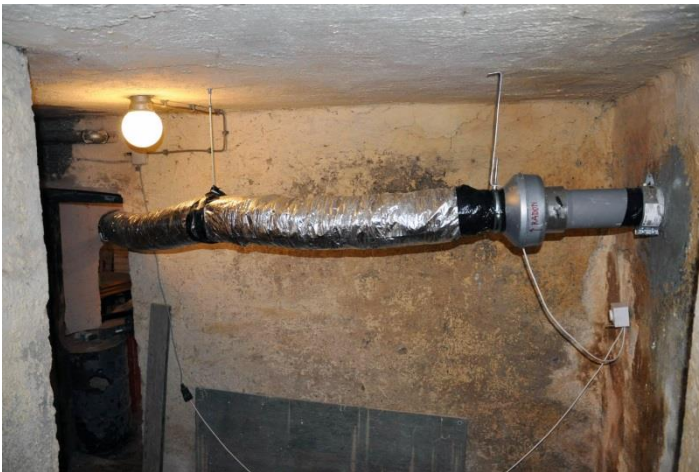
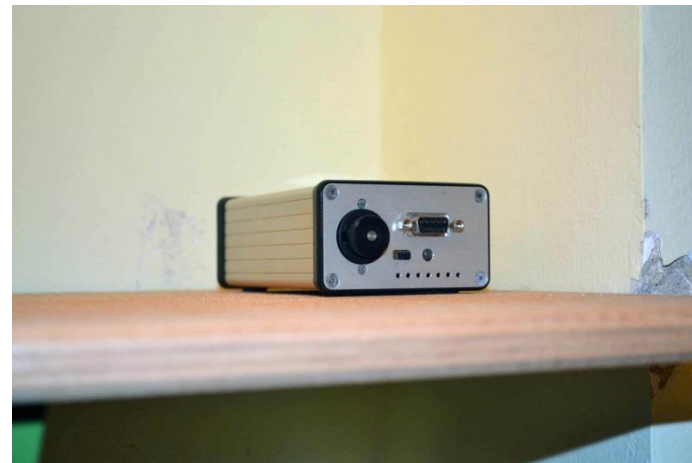
Case Vavta vas (2012-2013)

- Concentration dropped
 - Before: 1750 Bqm⁻³
 - After: 170 Bqm⁻³
- Whole solution approach
 - Design
 - Pilot installation
 - Unofficial measurements
 - Recommendations for improvements
- The system exhibited unexpected behaviour at first
- After adjustement good results
- However: due to lack of concern
 - No official measurements ordered so far
 - No proper commissioning done
